# ENGLISHTOWN LAKE DAM

**NJ 00619**

## PHASE 1 INSPECTION REPORT NATIONAL DAM SAFETY PROGRAM

JULY 1981

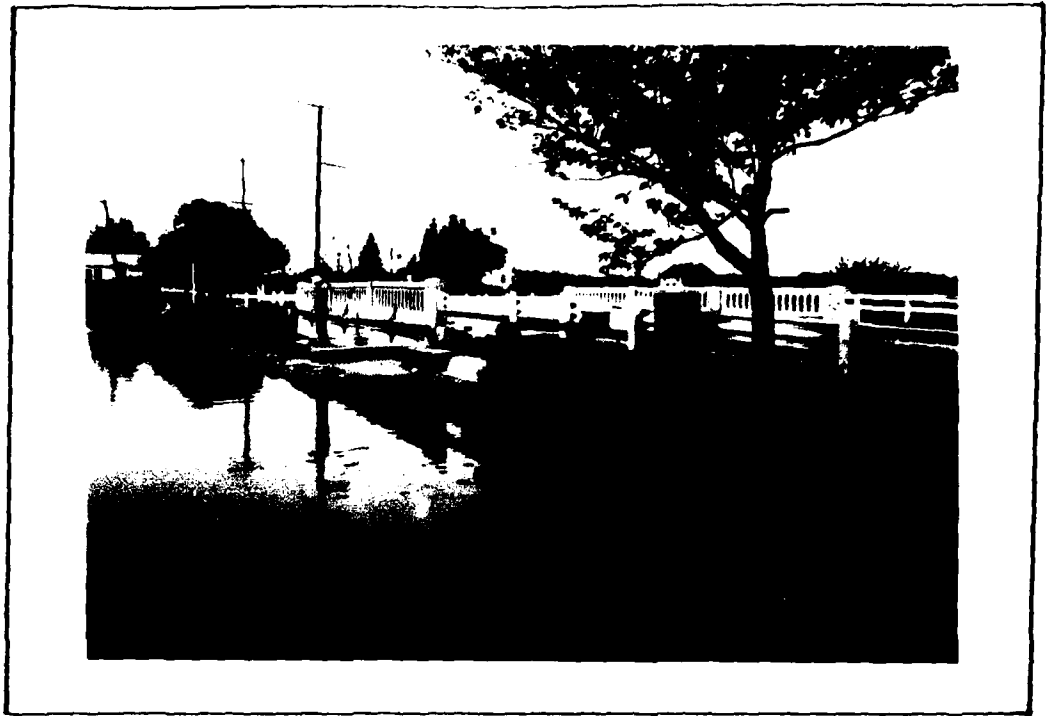
1. UPSTREAM FACE OF THE DAM AS OBSERVED FROM THE RIGHT ABUTMENT.  
(4/30/81)

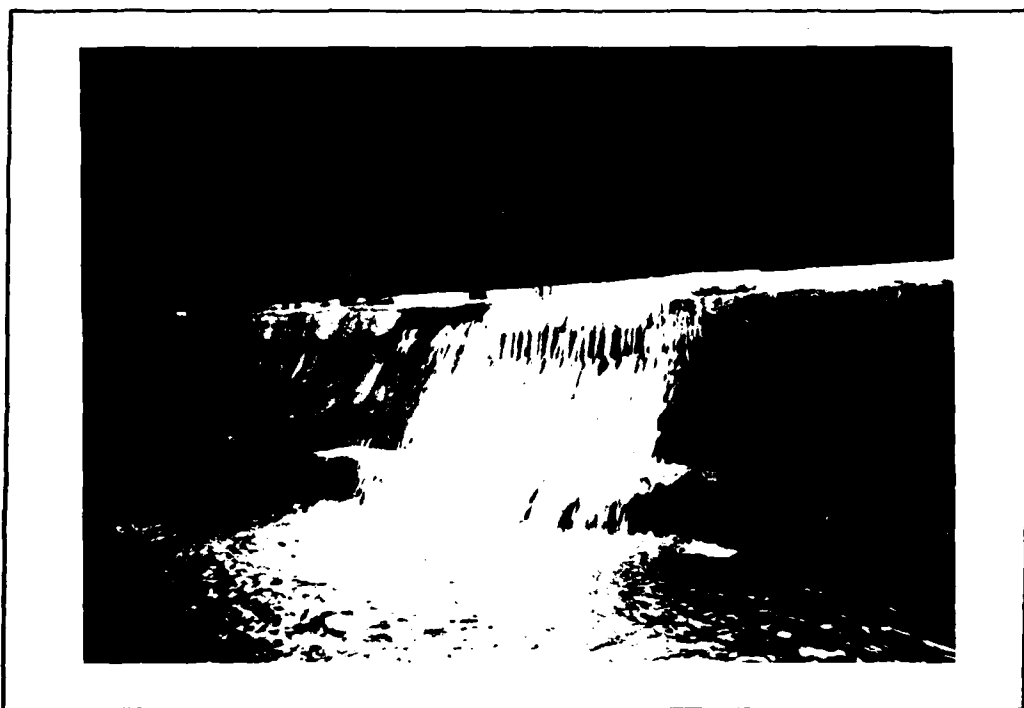
4. SPILLWAY AND RESERVOIR DRAIN GATE AS SEEN FROM BENEATH THE HIGHWAY BRIDGE. (4/30/81)

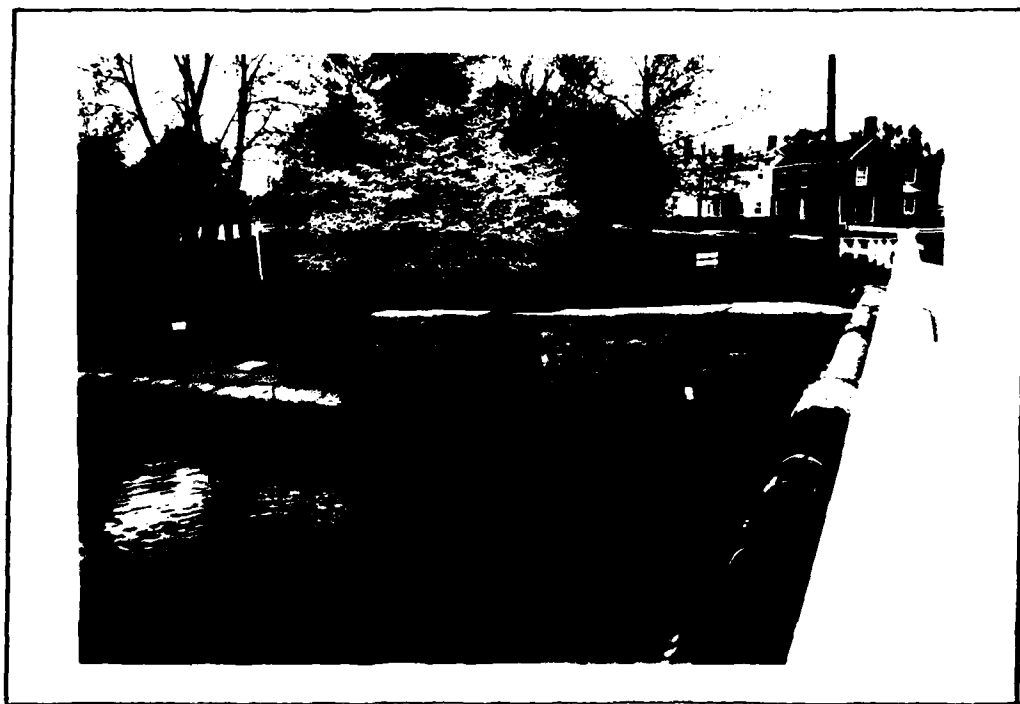
The spillway appears to be structurally tied into the abutments of the highway bridge. The bridge abutments appear to be a concrete/masonry composite. Cracks which appear to be structural, were noted in both bridge abutments. Superficial cracking and spalling was also evident in the bridge abutments.

10. THE RIGHT DOWNSTREAM ABUTMENT WALL OF THE BRIDGE. (4/30/81)
